## Sprinkler System Inspection Report

No.: 01204  
Date: 04/03/2024

| Building Name | Kerry's Place |

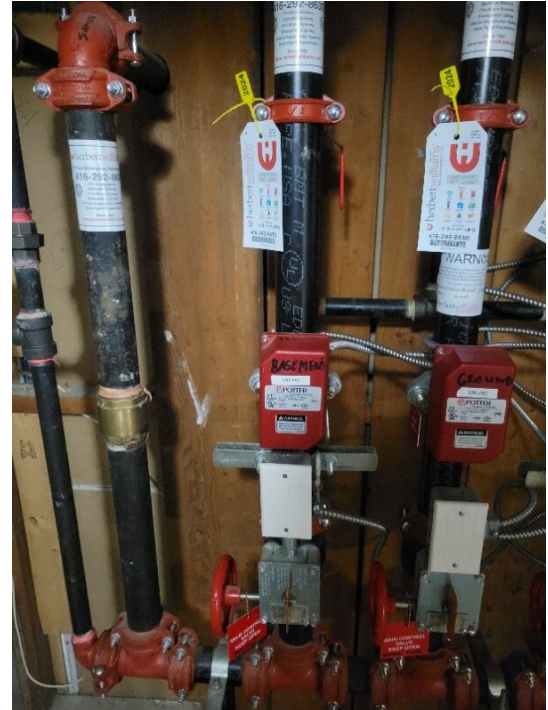
| System | Basement |

| Type | 2" butterfly - grooved |
| Cycled | Yes |
| Operational | Yes |
| Left open | Yes |
| Lock/Supervised | Supervised |
| Deficiencies | |
| None | |

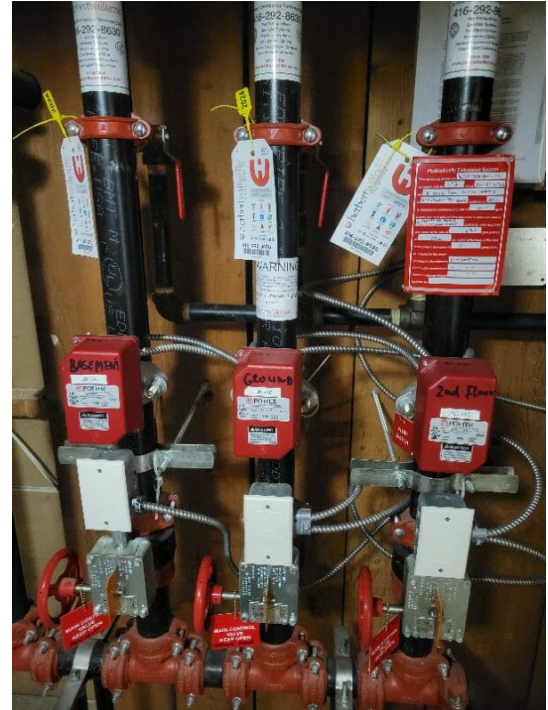
| System | 1st Floor |

| Type | 2" butterfly - grooved |
| Cycled | Yes |
| Operational | Yes |
| Left open | Yes |
| Lock/Supervised | Supervised |
| Deficiencies | |
| None | |

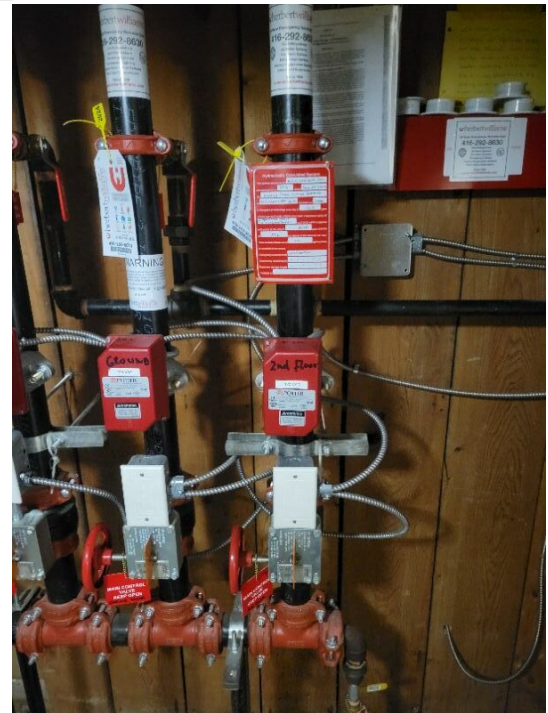
| System | 2nd Floor |

| Type | 2" butterfly - grooved |
| Cycled | Yes |
| Operational | Yes |
| Left open | Yes |
| Lock/Supervised | Supervised |
| Deficiencies | |
| None | |

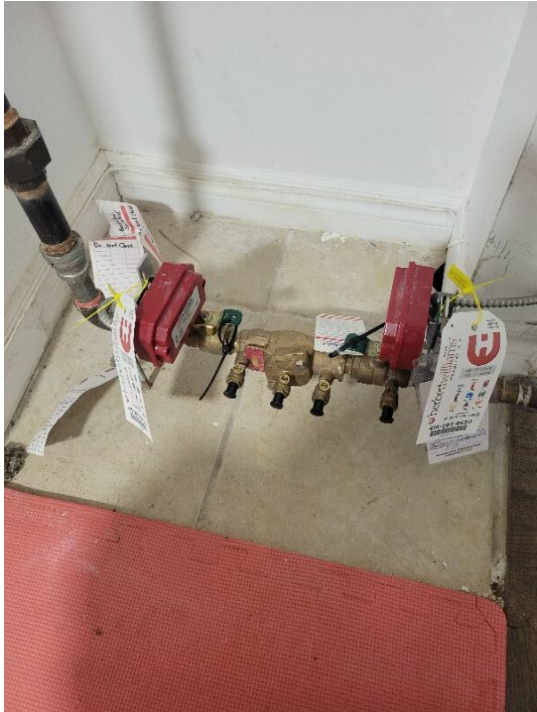
| Location of Backflow Device | Unit 1 Basement - exercise room |

| Make | Watts |
| Model | 007M3 |
| Cycled | Yes |
| Left open | Yes |
| Lock/Supervised | Supervised |
| Deficiencies | |
| None | |
