# Annual Emergency Lighting Test Report

## Annual Fire Extinguisher and Fire Hose Inspection Report

## Sprinkler System Inspection Report

| Building Name | Kerry's Place |

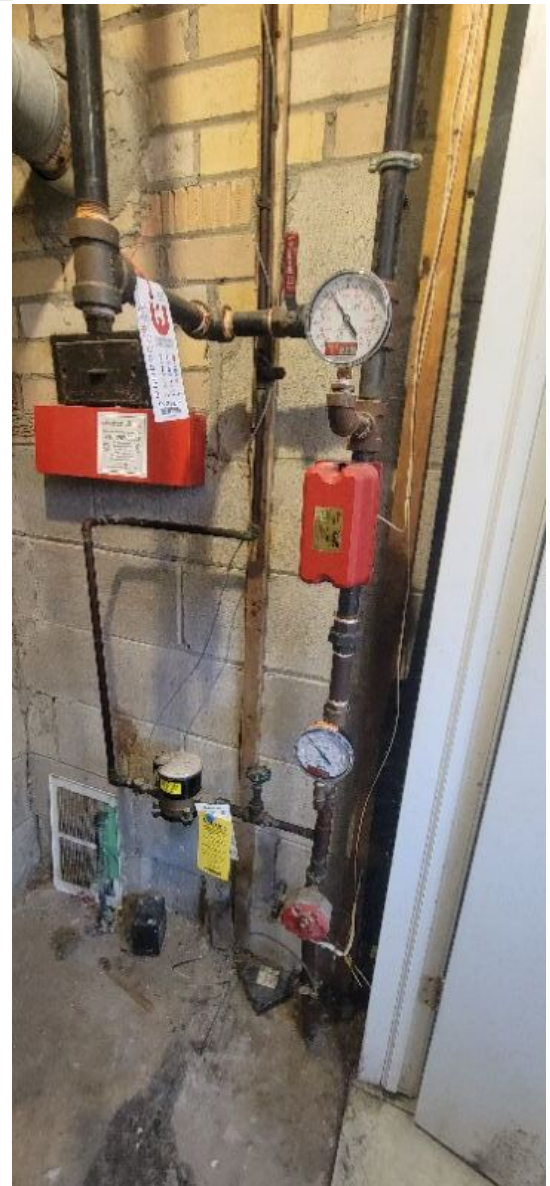
| Test Valve Location | Laundry room - furnace closet |
| Barcode - HWFID | HWF00252618 |

| Make/Model/Size Of Control Valve | 1" Milwaukee BB-SCS threaded |
