## Sprinkler System Inspection Report

No.: 01541  
Date: 02/04/2025

| Building Name | Kerry's Place |

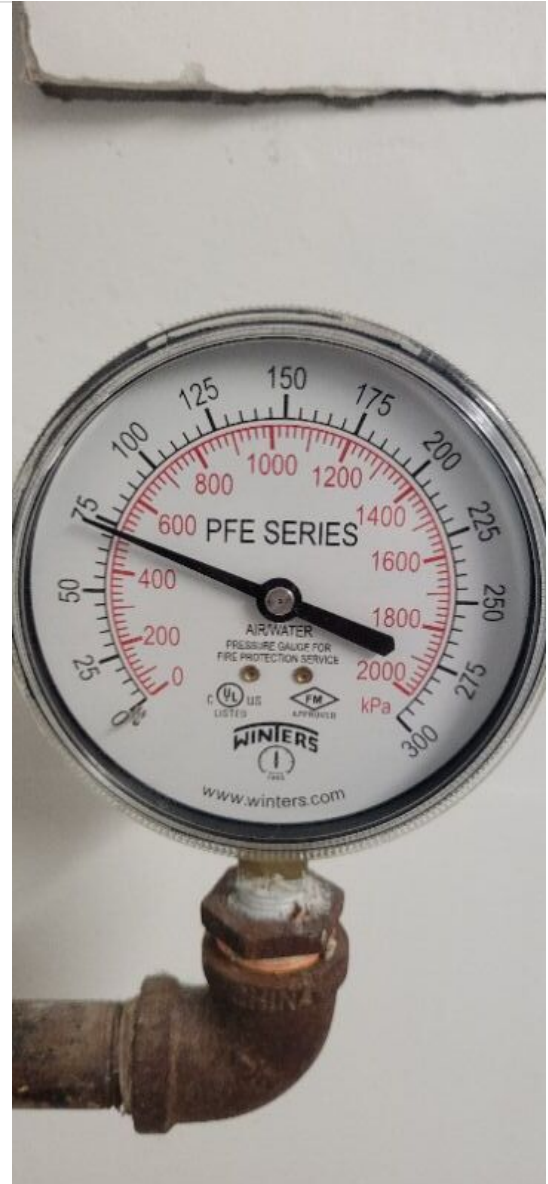
Photo 1

| Manufacturer Date of Gauges | 2020 |

| Def1 - Gauges require replaced x2, 5yr due. Install new 1/4" 3way valves (x2) when replacing gauges for future repair. | |

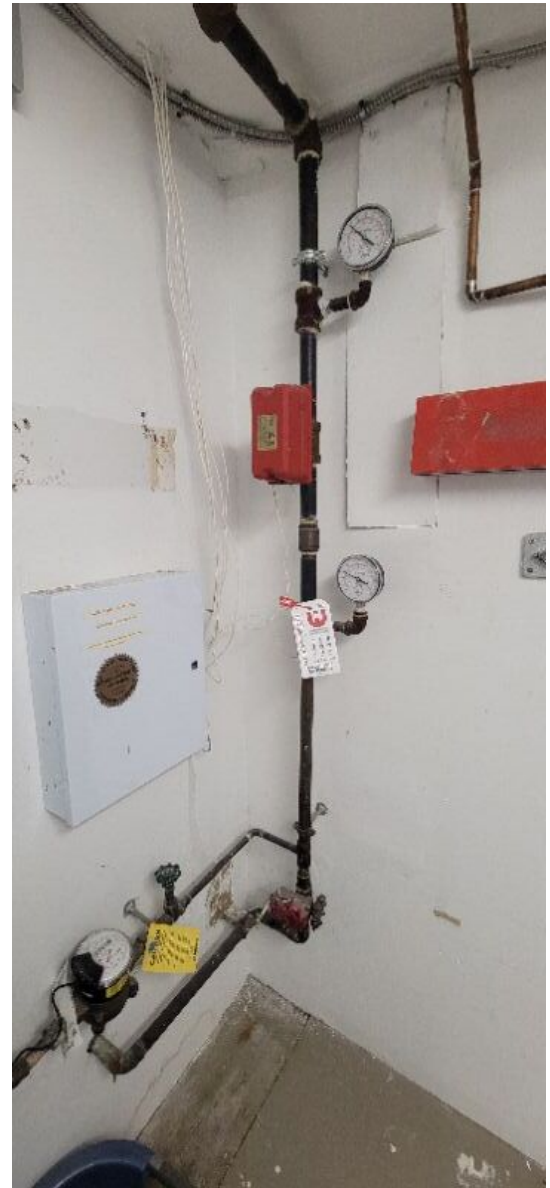
Photo

| Make/Model/Size Of Control Valve | 1" butterfly - threaded |
